**MATERIALS-COOLANT INTERACTIONS
RELEVANT TO EBR-II**

**W. E. Ruther, T. D. Claar,
S. Greenberg, and R. V. Strain**

EBR-II Project

April 1971

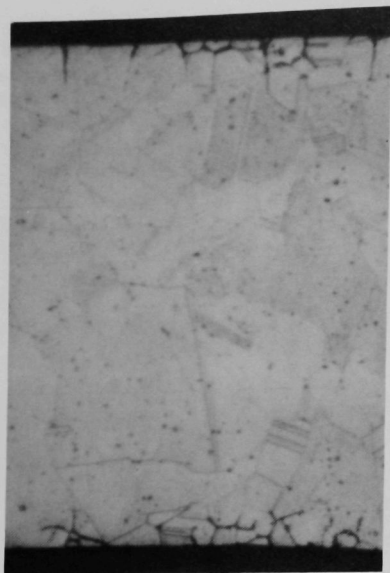
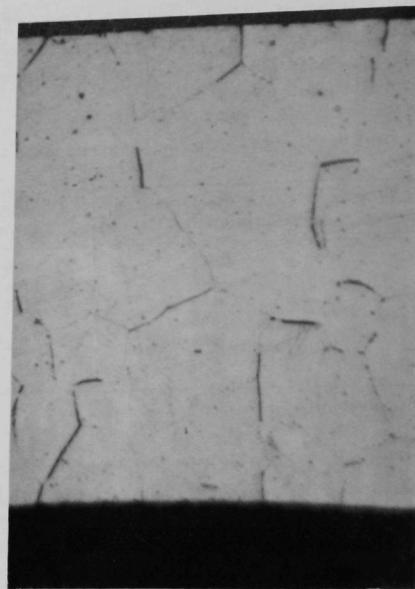
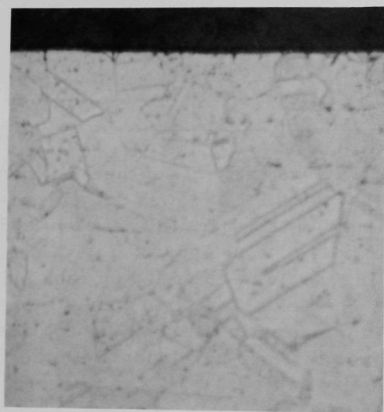
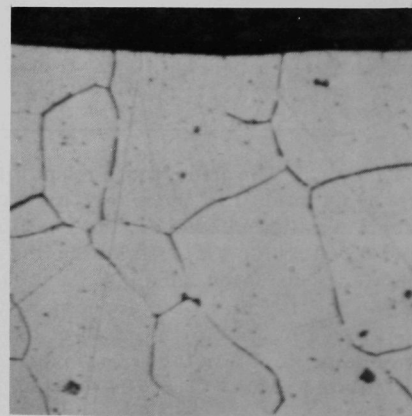
The nonhomogeneous microstructure (Fig. 21) of the foils whose carbon content had increased indicated that the 0.04 wt % was not an equilibrium value. However, the equilibrium value is apparently between 0.036 and 0.054 wt %. Calculations using diffusivity data of Agarwala *et al.*⁹ indicated a diffusion zone of only 0.00125 in. should be expected on each side of the foil for this time at temperature. The actual diffusion zone, as measured by maximum depth of carbide formation in the grain boundaries, was approximately 0.001 in., a value that is in close agreement with the calculated value.

Fig. 21. Microstructures of Types 304 (TC08) and 304L (TC02) Stainless Steel Equilibration Foils after Exposure in EBR-II (etched 45 sec in 5% oxalic acid). Mag. 400X.

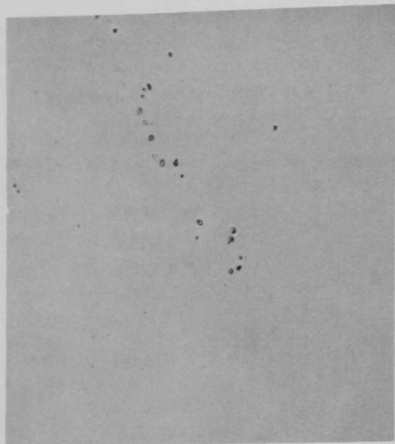
The specimens for these tests had been electropolished before exposure. A comparison of the as-electropolished unexposed and sodium-exposed surfaces (Figs. 28 and 29) shows that nitrides formed both on the grain boundaries and on the grain faces having intimate contact with nitrogen-containing sodium.

Fig. 28. As-electropolished Type 304 Stainless Steel Surface before Exposure to Hot Sodium under Ar-0.1 vol % N_2 Cover Gas. Mag. 900X.
